HomeBuyers Inspection HBI

Cognitive Sample 2

Route 1 Box 210
Rural Town, SC 28991

Wednesday, March 07, 2001

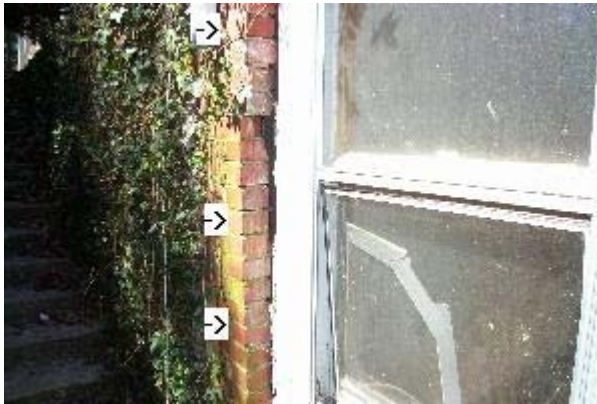
2.2 CONDITION OF EXTERIOR SIDING

Comments: See Comments

Brick siding at right side (facing front) is loose, and needs mortar and repair as necessary.

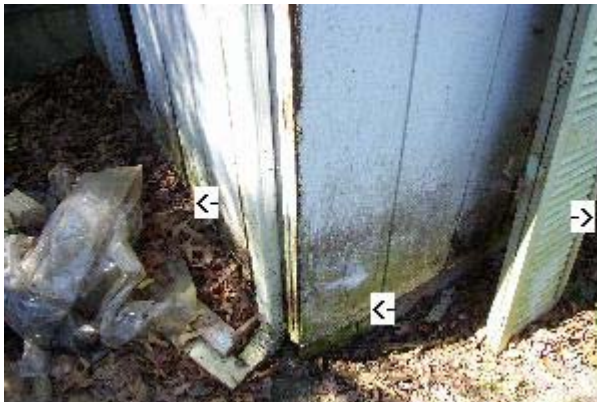
2.3 EXTRA VIEW OF SIDING

Comments: See Comments

Siding deteriorated under washer dryer room.

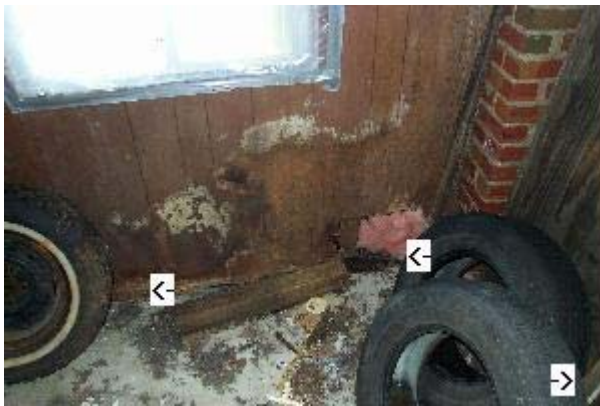
3.0 FOUNDATION WALLS AND MORTAR JOINTS

Comments: See Comments

Wood stud walls deteriorated under washing machine room.

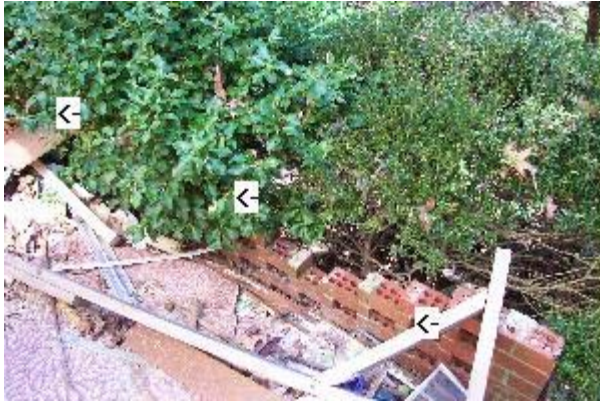
3.4 DECKS, STAIRS AND HANDRAILS

Comments: See Comments

Guardrails and pickets on Porch at right side of home (facing front) missing. Recommend install rail with maximum space between pickets to be four inches (where platform exceeds 30 inches from ground).

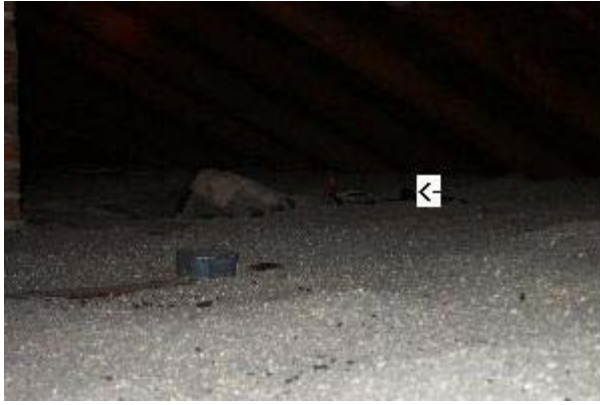
5.7 ARE THERE ANY UNSAFE ELECTRICAL WIRING IN ATTIC

Comments: Yes, See Comments

One electrical splice is missing box and coverplate above Kitchen. Recommend a Licensed electrician correct.

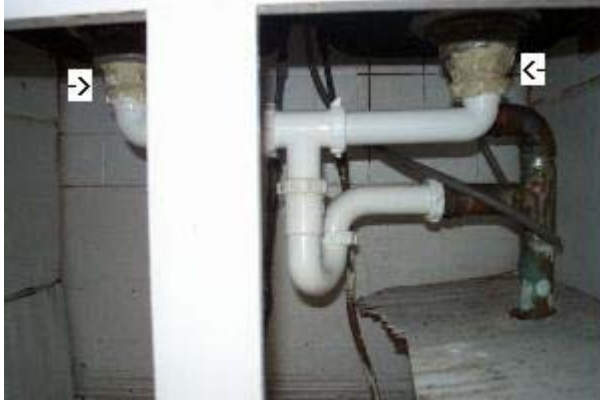
7.1 CONDITION OF PLUMBING UNDER SINK

Comments: See Comments

Basket strainer has improper connections or repairs. Recommend a licensed plumber correct at Downstairs Kitchen.

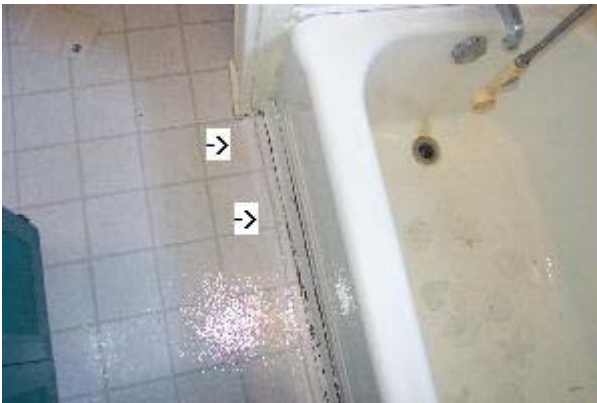
**Comments:** Fair
Subfloor is deteriorated or weak along bathtub.**11.4.A DOORS****Comments:** Fair, See Comments

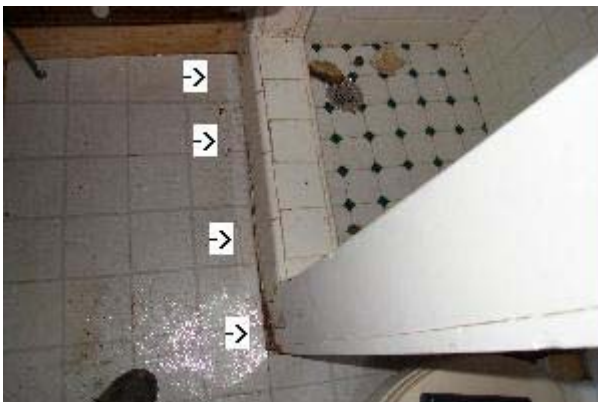
**Comments:** See Comments

Subfloor is deteriorated or weak along threshold of shower and is deteriorated or weak around

Subfloor is deteriorated or weak along threshold of shower and is deteriorated or weak around toilet.

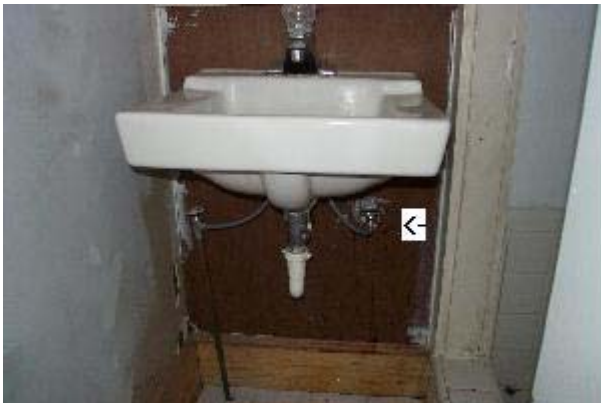
12.2 ARE CUT-OFF VALVES UNDER SINK AND TOILET

Comments: Yes, See Comments

Sink supply valve is leaking, and needs repair at Downstairs Bath.

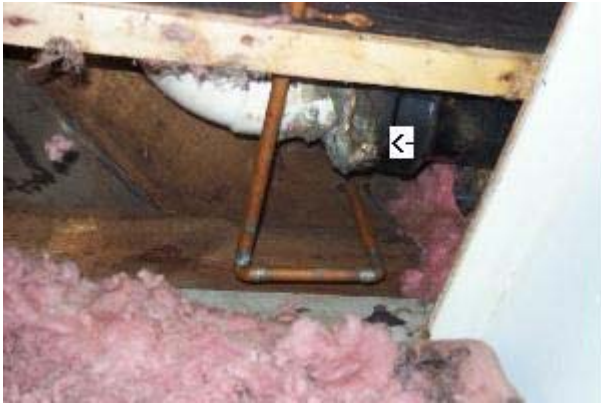
12.5 DOES TOILET OPERATE PROPERLY

Comments: Yes, See Comments

Rusted connection from tank to toilet at upstairs bath. Also toilet leaks at connection to main soil pipe (can be seen from access panel at ceiling downstairs. Toilet is loose at floor . Repair may involve resetting the toilet on a new wax seal at Downstairs Bath.

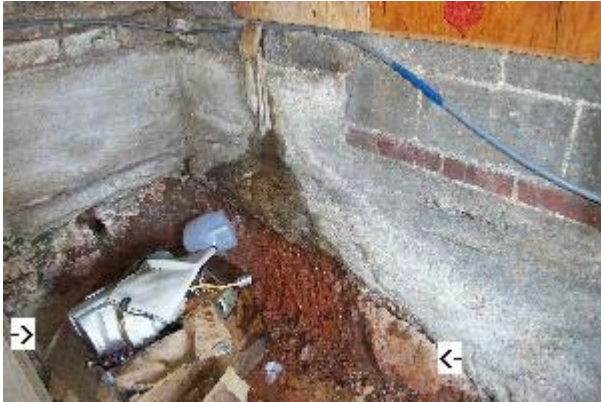
14.0 FOUNDATION WALLS

Comments: Fair, See Comments

The foundation walls have been "under cut" many years ago from inside basement. Ground or dirt that helped support the footing has been removed. This weakens the structure and usually requires repair by building retaining walls. If a structural engineer determines that this condition shows no signs of failure, or that repairs are not needed at this time, He or She will give you a letter saying the structure is safe. If the engineer determines repairs are needed, He or She will design the proper repair. Only a structural engineer can determine the type of repair that may be needed.

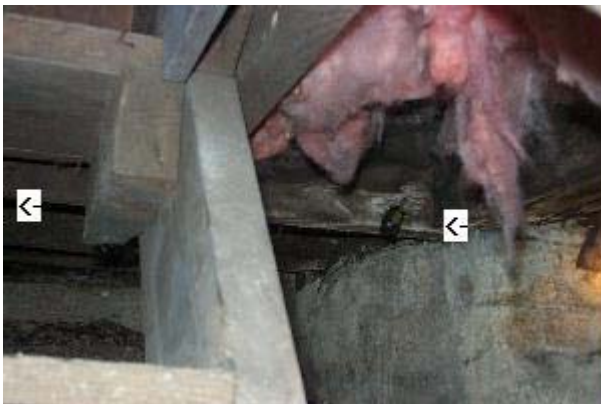
14.1 FLOOR SYSTEM

Comments: See Comments

Floor system deteriorated under discontinued stairs. Repairs needed.

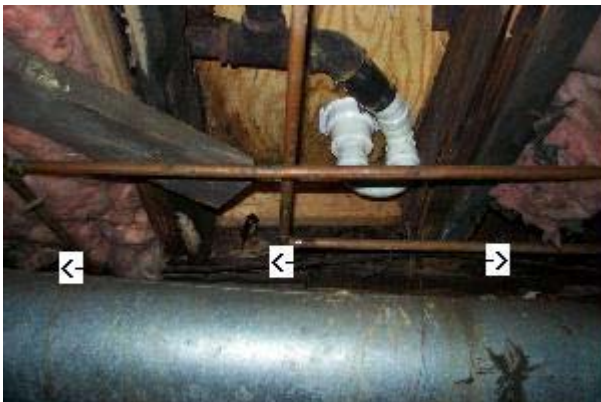
14.2 GIRDERS, PIERS, COLUMNS AND SUPPORTS

Comments: See Comments

Main girder is deteriorated. Repairs made are inadequate and need further repairs or replacement of girder. Recommend a structural engineer evaluate further. At least three supports under downstairs kitchen are missing.

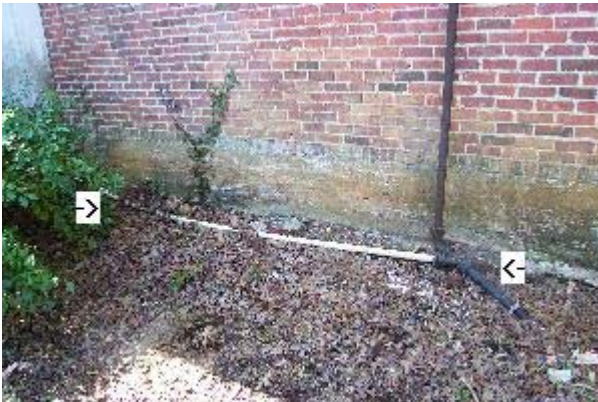
14.10 PLUMBING COMPONENTS AND CONDITION

Comments: Fair, See Comments

Clean out cap missing. Above ground plumbing may freeze in rear.

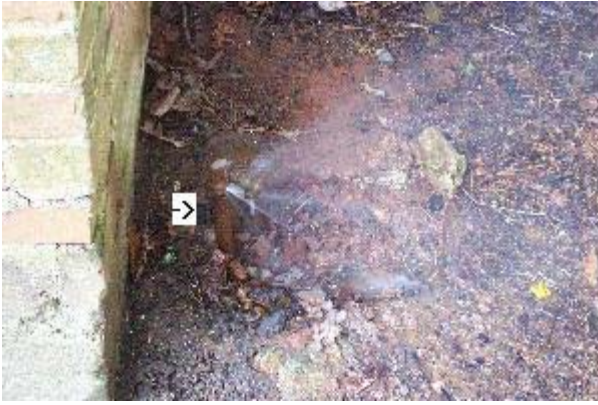
14.12 ANY LEAKS ON SUPPLY OR WASTE LINES

Comments: Yes, See Comments

Outside supply line to faucet is ruptured. Also at least two leaks in-line present on polybutelene supply.

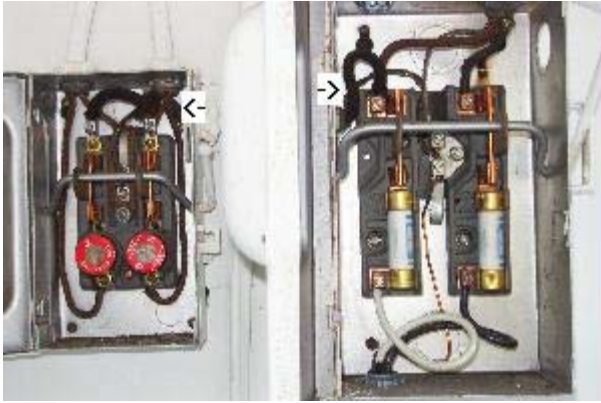
15.0 CONDITION OF MAIN SERVICE PANEL AND THE LOCATION

Comments: Fair, See Comments

Sub panels in Sunroom are double tapped at lugs and need correcting.

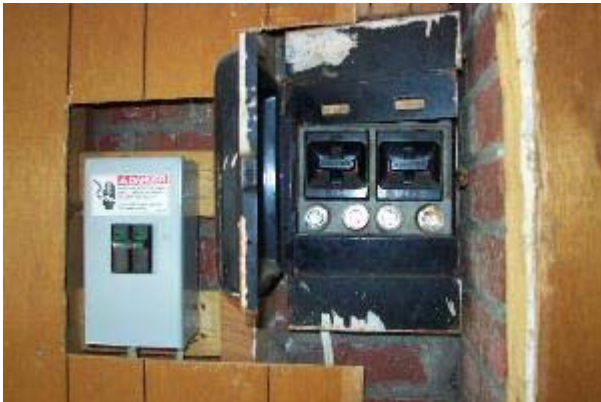
15.3 CONDITION OF WIRING, CIRCUITS, OR FUSES INSIDE MAIN PANEL

Comments: See Comments

Problem(s) discovered in panel such as Doubled wiring at fuse(s), Edison base fuse(s), Panel is overloaded, Service conductors are undersized, and any other problems that an electrician may discover while performing repairs need correcting. Recommend a licensed electrician inspect further and correct as needed.

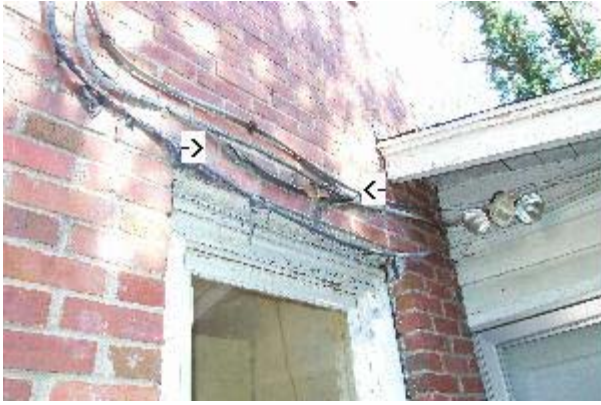
15.4 ANY LOOSE OR IMPROPER WIRING FOUND THROUGHOUT HOME

Comments: Yes, See Comments
Service conductors damaged.

Service conductors damaged.

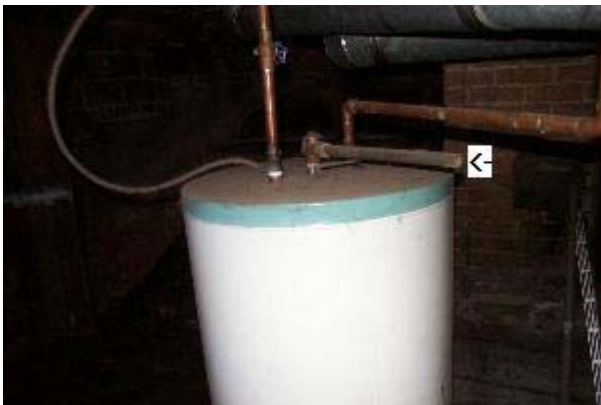
15.9 IS THE T&P VALVE PIPED WITHIN 6 INCHES OF FLOOR

Comments: See Comments, No

T&P (Test and Pressure) valve on water heater needs a 3/4 threaded pipe to extend within 6 inches of floor for safety. (PVC is not approved for hot water use).

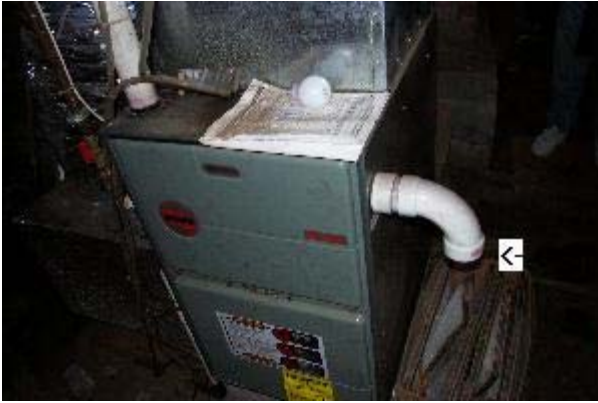
15.10 WAS THE CONDITION OF HEATING UNIT (S) TESTED

Comments: Yes, See Comments

Heat system did not work when tested. Also fresh air vent (see photo) does not pull fresh air from outside as required.

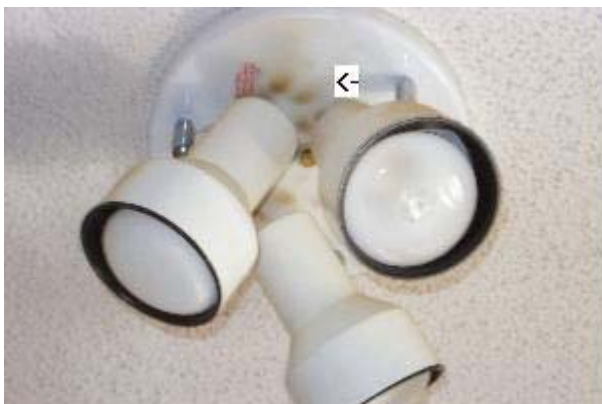
**Comments:** See Comments, No

Light fixture does work, but is damaged in Upstairs Kitchen (burn marks). Light fixture does not work and pull chain is missing in Upstairs bath. Light fixture does not work and needs repair (try bulb first) (above stairs to lower Level). Light fixture does not work and needs repair (try bulb first) downstairs in bath.
